Smoke and Dye Testing Summary

High Level Sewershed

Test ID	Test Type	Date Inspected	Company / Super.	Blower MH	Ground Condition	Notification Made?	Total Length
S1028-212	Smoke	8/4/2009	ADS/TM	S17C_022MH	Dry	Yes	1,001.69

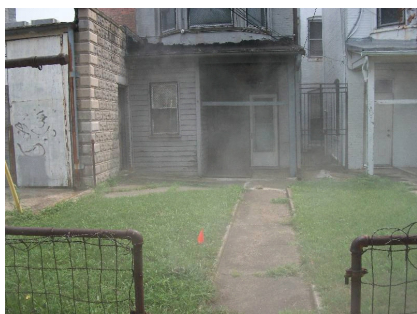
Picture \S1028-212-OB01-P01.jpg

Source Cleanout

Location Yard - back

Comments Smoke from cleanout in back yard. 2316 Edmondson Ave.

Comments Back of house, 2316 Edmondson Ave.

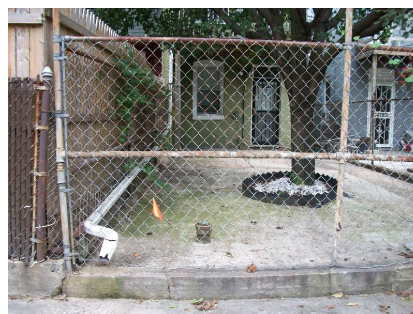
Picture \S1028-212-OB02-P01.jpg

Source Cleanout

Comments Smoke from above-grade cleanout in back yard. 2416 Edmondson Ave.

Comments Back of house, 2416 Edmondson Ave.

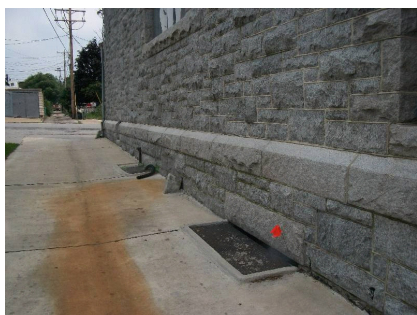
Picture \S1028-212-OB03-P01.jpg

Source Foundation Drain

Comments Smoke from foundation drain in alley next to church. 2500 Edmondson Ave.

Comments Side of church, 2500 Edmondson Ave. looking towards Warwick Ave.

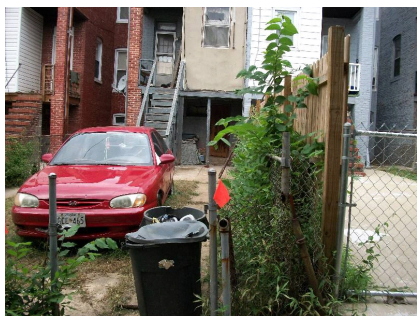
Picture \S1028-212-OB05-P01.jpg

Source Service Lateral

Comments Smoke from service lateral under paved concrete in back yard. 2523 Arunah Ave.

Comments Back of house, 2523 Arunah Ave.

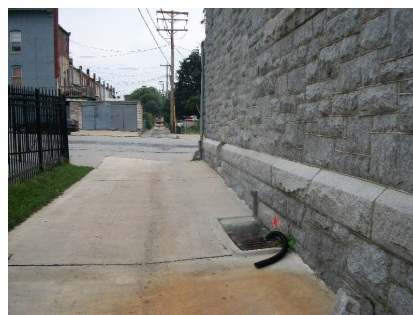
Picture \S1028-212-OB04-P01.jpg

Source Foundation Drain

Comments Smoke from foundation drain in alley next to church. 2500 Edmondson Ave.

Comments Side of church, 2500 Edmondson Ave. looking towards Warwick Ave.

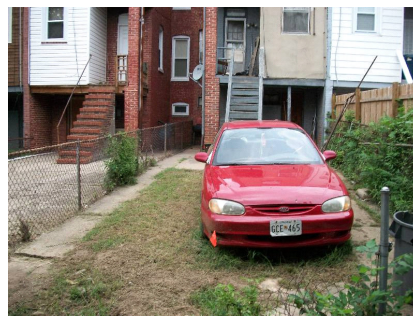
Picture \S1028-212-OB06-P01.jpg

Source Service Lateral

Comments Smoke from service lateral in back yard. 2523 Arunah Ave.

Comments Back of house, 2523 Arunah Ave.

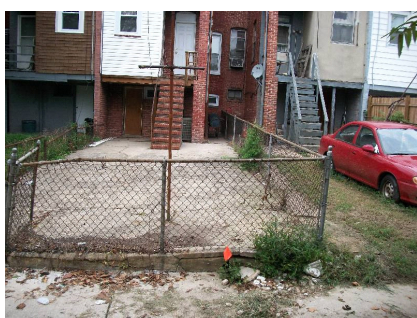
Picture \S1028-212-OB07-P01.jpg

Source Service Lateral

Comments Smoke from service lateral under paved concrete in back yard. 2525 Arunah Ave.

Comments Back of house, 2525 Arunah Ave.
